**Report: Chilt/RF11067
Revision A**

**A fire resistance test performed on
eighteen pipe penetration sealing
systems within a flexible supporting
construction**

**Test conducted in accordance with
BSEN 1366-3: 2009
Test date: 11th May 2011**

**Prepared for: Tenmat Ltd
Ashburton Road West
Trafford Park
Manchester
M17 1RU**

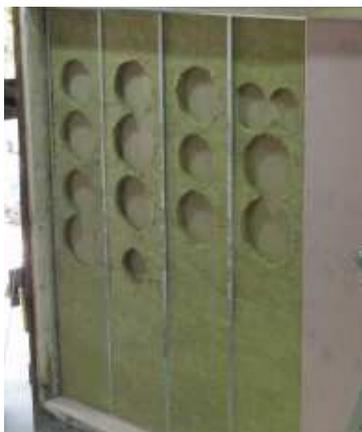
The mineral wool insulation was removed for 100mm surrounding the cut out apertures (see below).

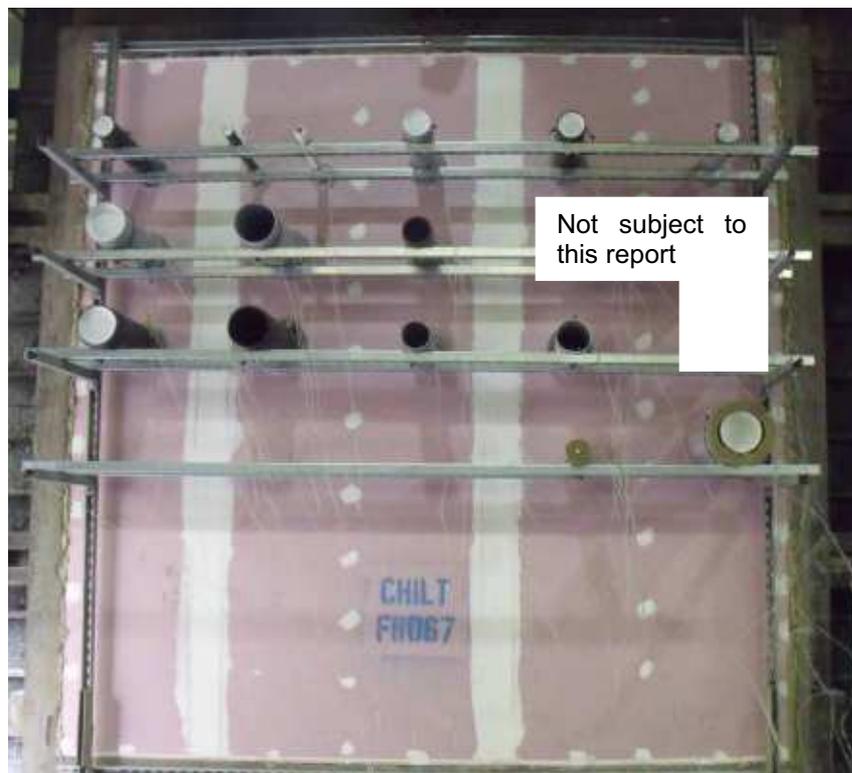
Unexposed face supporting construction

On the unexposed face, 2No 3000mm Unistrut sections were used as vertical supports, bracketed to 2No. Unistrut sections fixed at the top and bottom of the restraint frame. 8No 500mm long Unistrut cantilever arm sections provided support for Unistrut ‘U’ section channels supporting the pipes at 150mm and 450mm from the wall. All specimens were fixed to the supporting Unistrut ‘U’ section channels using cable ties.

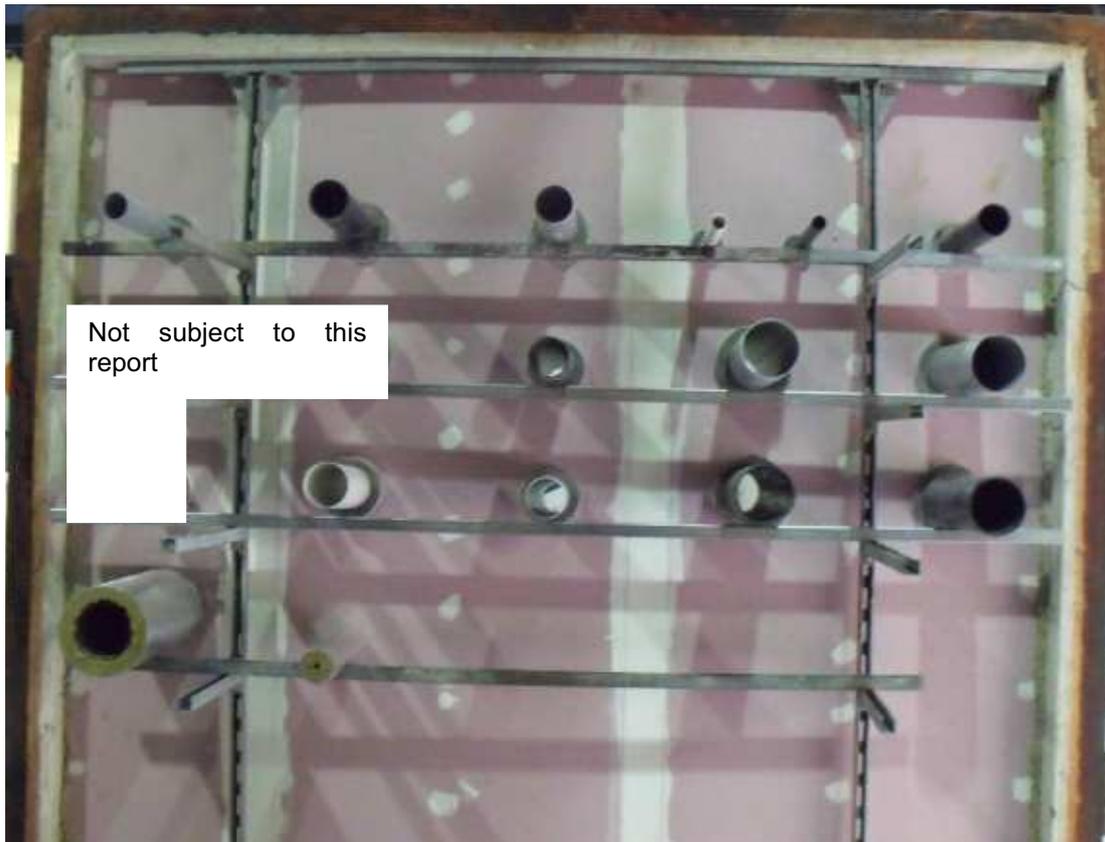
Exposed face support system

On the exposed face, 2No 3000mm Unistrut sections were used as vertical supports, bracketed to 2No. Unistrut sections fixed at the top and bottom of the restraint frame. 8No 500mm long Unistrut cantilever arm sections provided support for 4No horizontal lengths of Unistrut, supporting the pipes at 300mm from the wall. All pipes were not fixed to the supports.

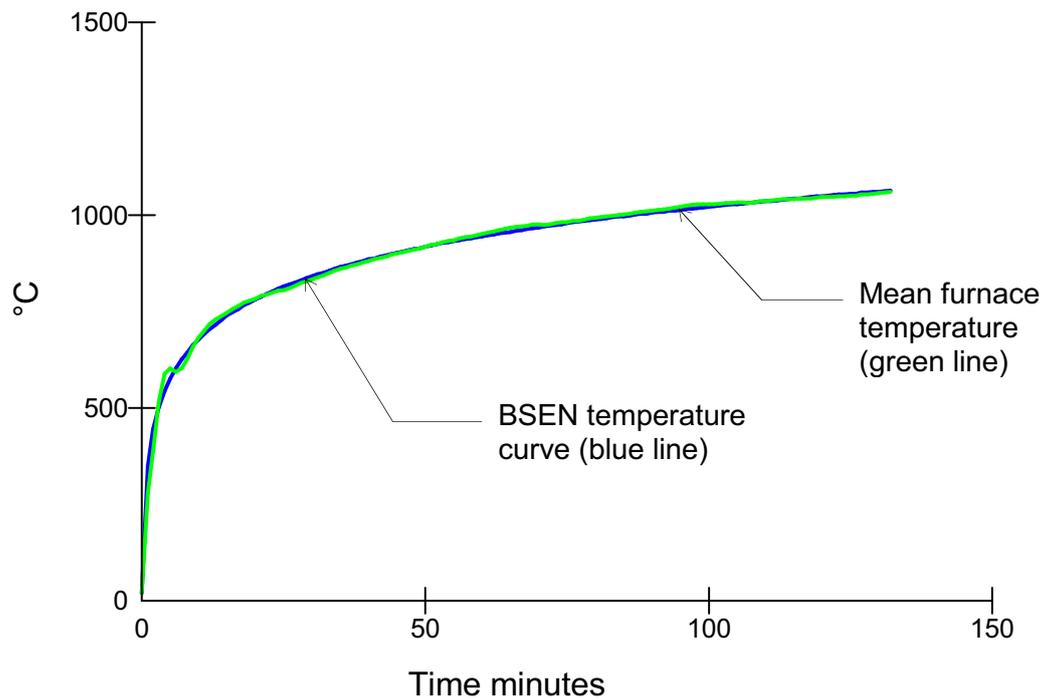
The furnace was controlled to follow the temperature/time relationship specified in BSEN 1363: Part 1: 1999 Section 5.1.1 as closely as possible, using the average of nine plate thermometers suitably distributed within the furnace. The temperatures recorded have been tabulated in Appendix 2 and are shown graphically below:

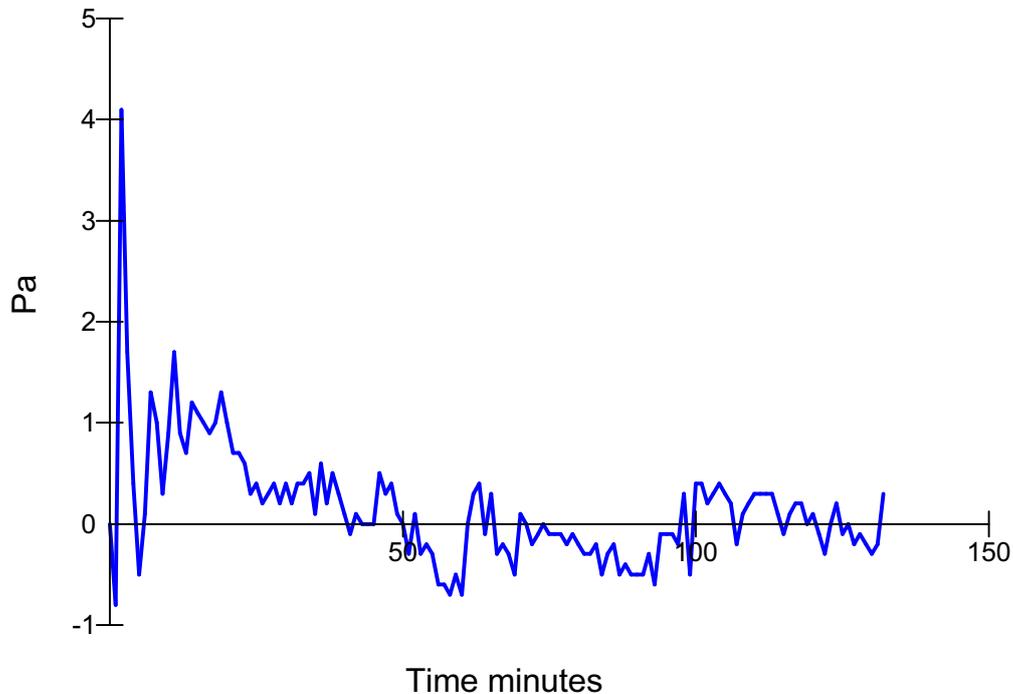
After the first 5 minutes of the test, the furnace pressure was maintained at 0.5 ± 5 Pa and after 10 minutes was maintained at 0.5 ± 3 Pa with respect to atmosphere, at a point 0.5m from the notional floor level. Therefore equating to 10 Pa at the base of penetration seals 12, 13, 14, 15 and 16. The pressure readings have been tabulated in Appendix 2 and are shown graphically below:

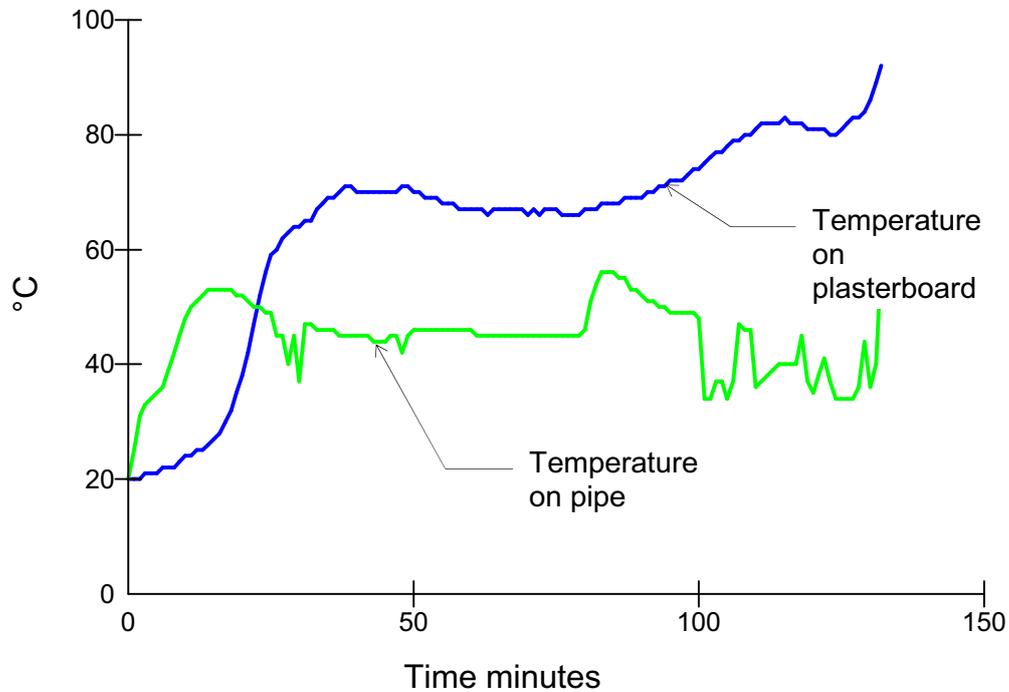
Pipe 1

Unexposed face temperature curves

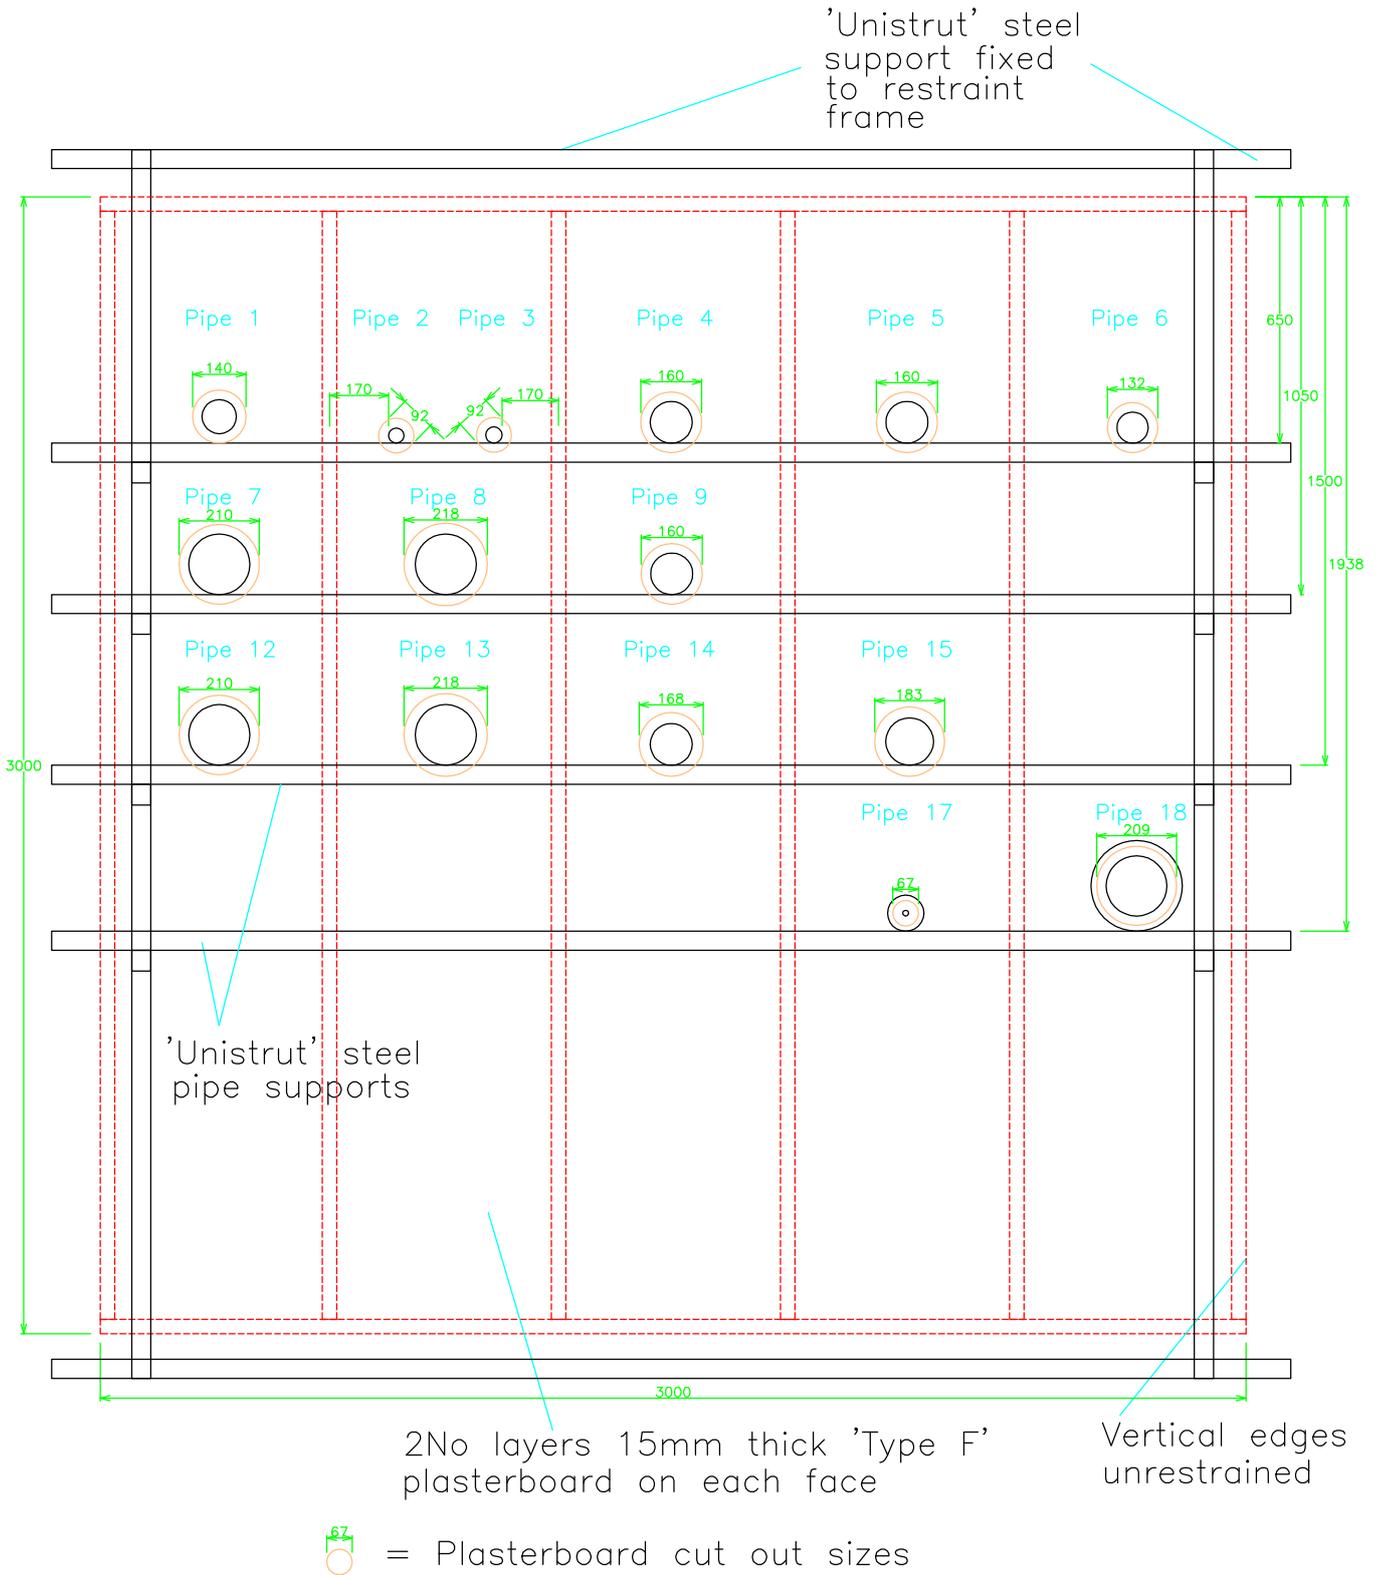
Title
 Unexposed face front elevation showing studwork and pipe supports
 (All dimensions in mm)

All comments relate to the unexposed face unless otherwise specified, (reference to Appendix 1 - figure 1).

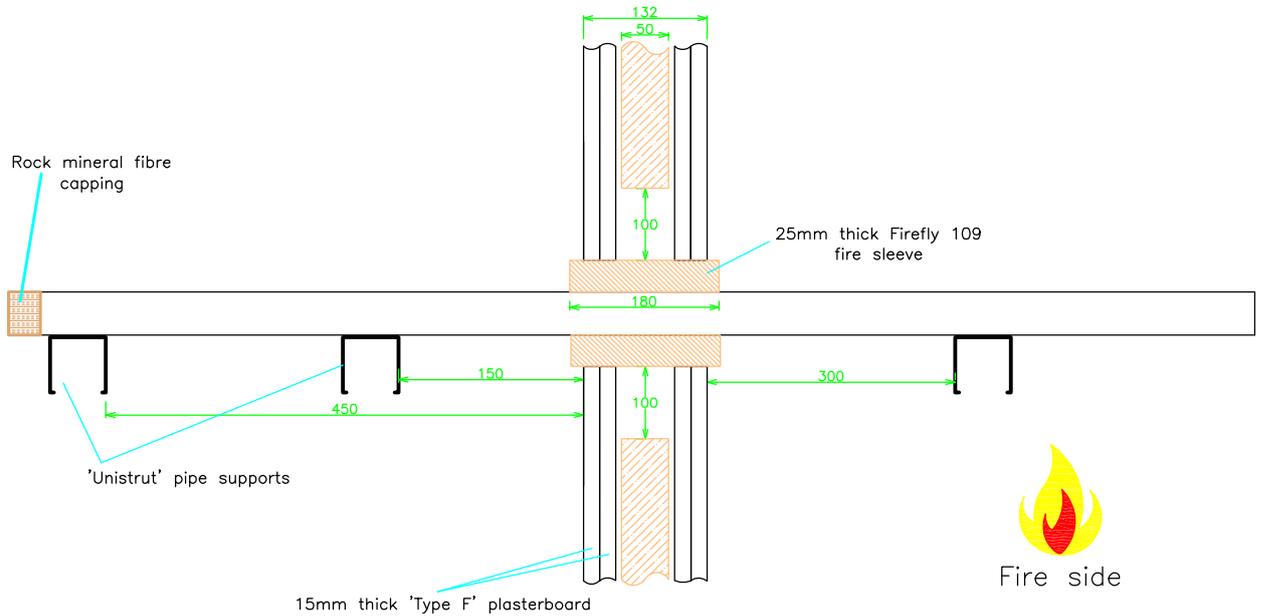
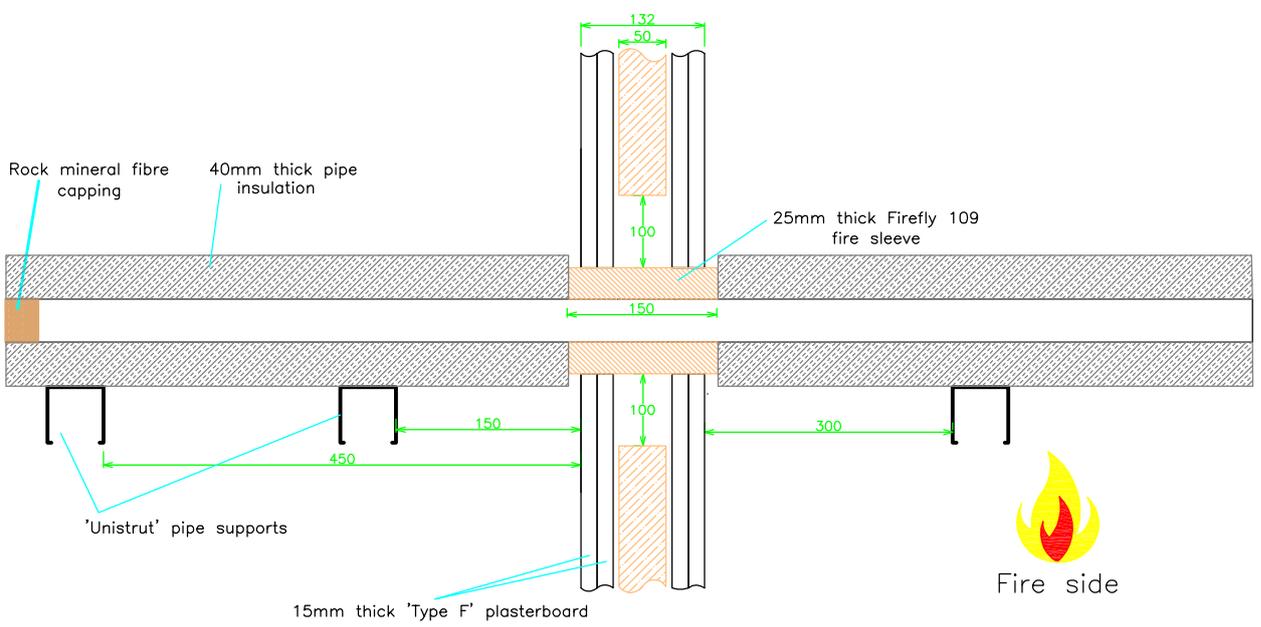
Pipe sealing system
pipes 1 to 7 and 12

Pipe sealing system
pipes 17 and 18

Title Cross section of pipe seals
1 to 7, 12, 17 and 18

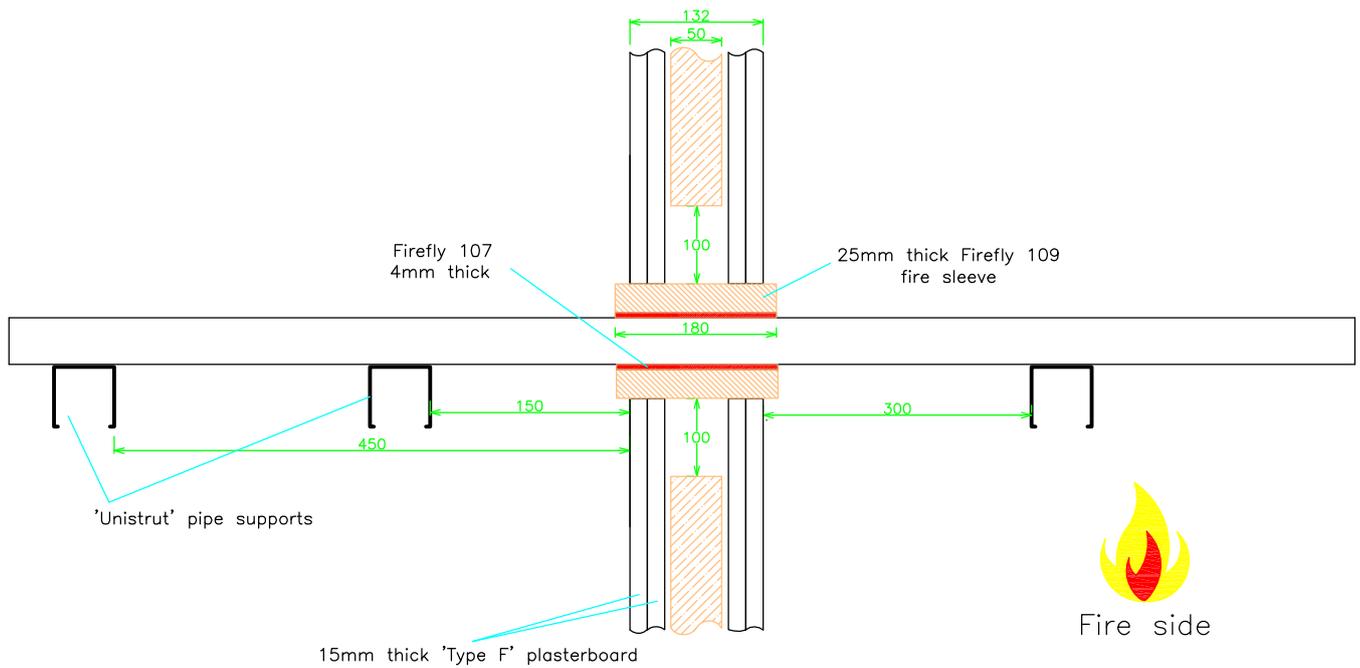
Pipe sealing systems
8, 9, 13 and 14

Title
Cross section of pipe seals
8, 9, 13 and 14

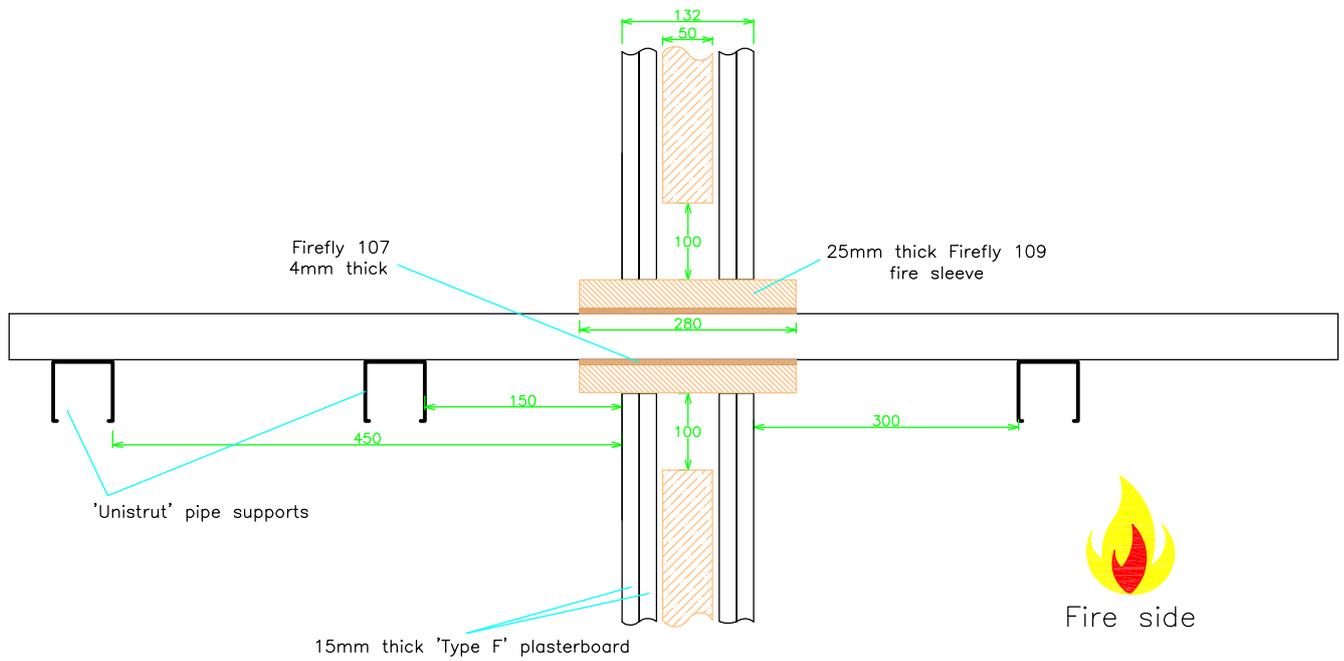
Pipe sealing system
15

Title
Cross section of pipe seal 15

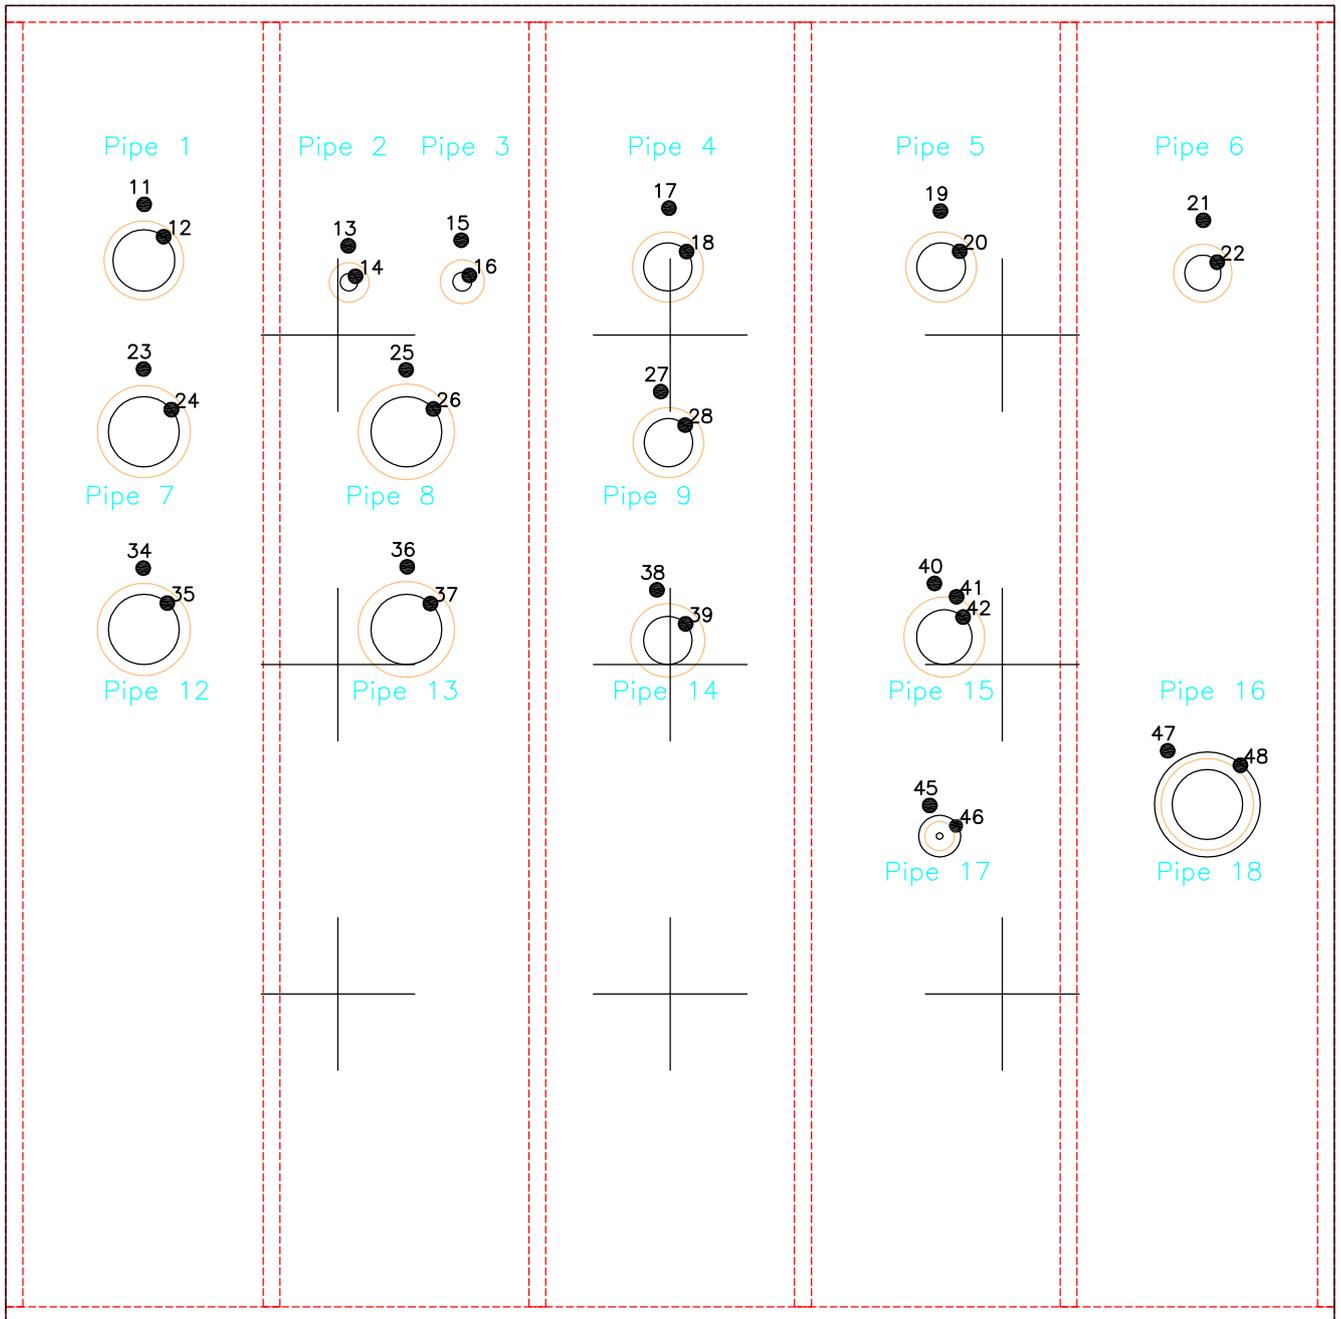
: Furnace Thermocouples

5.4 Thermocouple positions (see Appendix 1 figure 5)

Thermocouple Number	Pipe reference	Type (location)
1	-	Furnace
2	-	Furnace
3	-	Furnace
4	-	Furnace
5	-	Furnace
6	-	Furnace
7	-	Furnace
8	-	Furnace
9	-	Furnace
10	-	Not used
11	1	Fitted on plasterboard 25mm from firesleeve
12	1	Fitted on pipe 25mm from plasterboard
13	2	Fitted on plasterboard 25mm from firesleeve
14	2	Fitted on pipe 25mm from plasterboard
15	3	Fitted on plasterboard 25mm from firesleeve
16	3	Fitted on pipe 25mm from plasterboard
17	4	Fitted on plasterboard 25mm from firesleeve
18	4	Fitted on pipe 25mm from plasterboard
19	5	Fitted on plasterboard 25mm from firesleeve
20	5	Fitted on pipe 25mm from plasterboard
21	6	Fitted on plasterboard 25mm from firesleeve
22	6	Fitted on pipe 25mm from plasterboard
23	7	Fitted on plasterboard 25mm from firesleeve
24	7	Fitted on pipe 25mm from plasterboard
25	8	Fitted on plasterboard 25mm from firesleeve
26	8	Fitted on pipe 25mm from plasterboard
27	9	Fitted on plasterboard 25mm from firesleeve

28	9	Fitted on pipe 25mm from plasterboard
34	12	Fitted on plasterboard 25mm from firesleeve
35	12	Fitted on pipe 25mm from plasterboard
36	13	Fitted on plasterboard 25mm from firesleeve
37	13	Fitted on pipe 25mm from plasterboard
38	14	Fitted on plasterboard 25mm from firesleeve
39	14	Fitted on pipe 25mm from plasterboard
40	15	Fitted on plasterboard 25mm from Firesleeve
41	15	Fitted on Firesleeve 25mm from plasterboard
42	15	Fitted on pipe 25mm from Firesleeve
45	17	Fitted on plasterboard 25mm from firesleeve
46	17	Fitted on pipe insulation 25mm from plasterboard
47	18	Fitted on plasterboard 25mm from firesleeve
48	18	Fitted on pipe insulation 25mm from plasterboard
49	-	Laboratory ambient
